**REPORT TO:** CITY GOVERNANCE COMMITTEE - 22 SEPTEMBER 2025

**REPORT ON:** OLYMPIA

**REPORT NO:** 246-2025

- 1.1 The purpose of this Report is to enable the Council to scrutinise the Report by Burness Paull, Solicitors, regarding the closure of the Olympia Swimming and Leisure Centre in 2024 following £6.1m of capital investment by Dundee City Council.

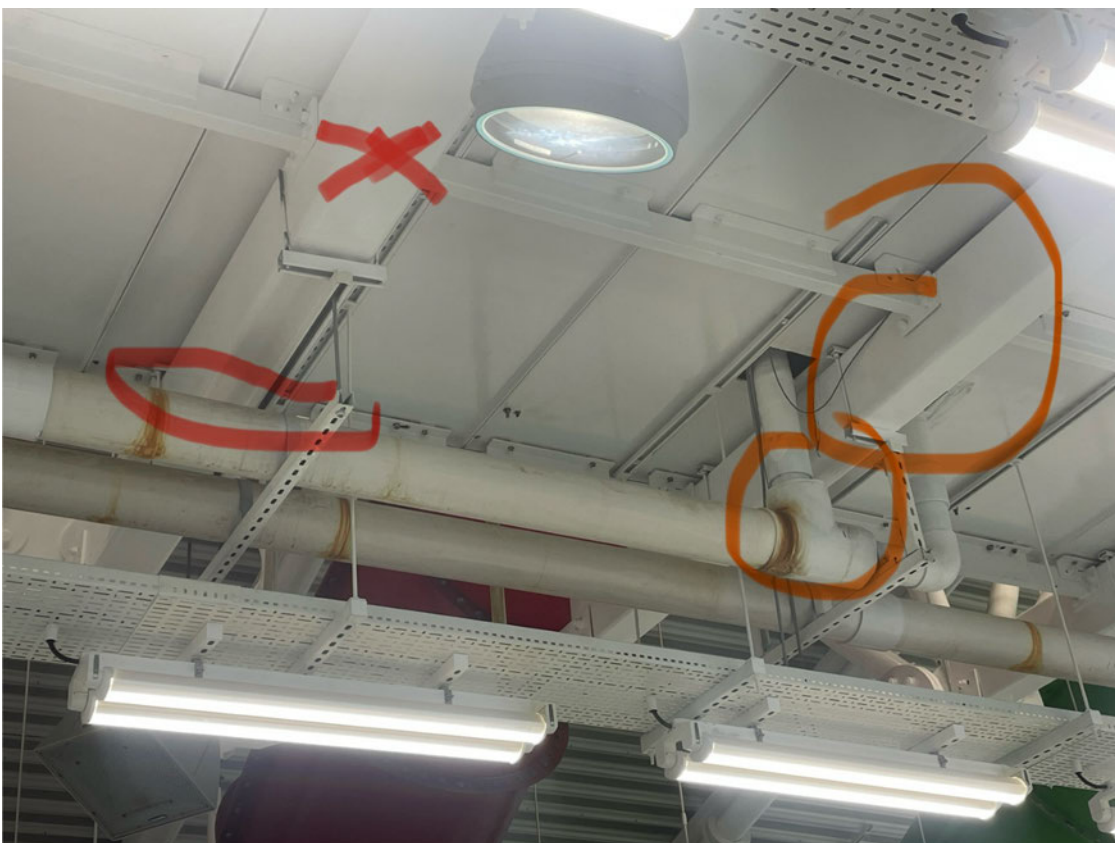
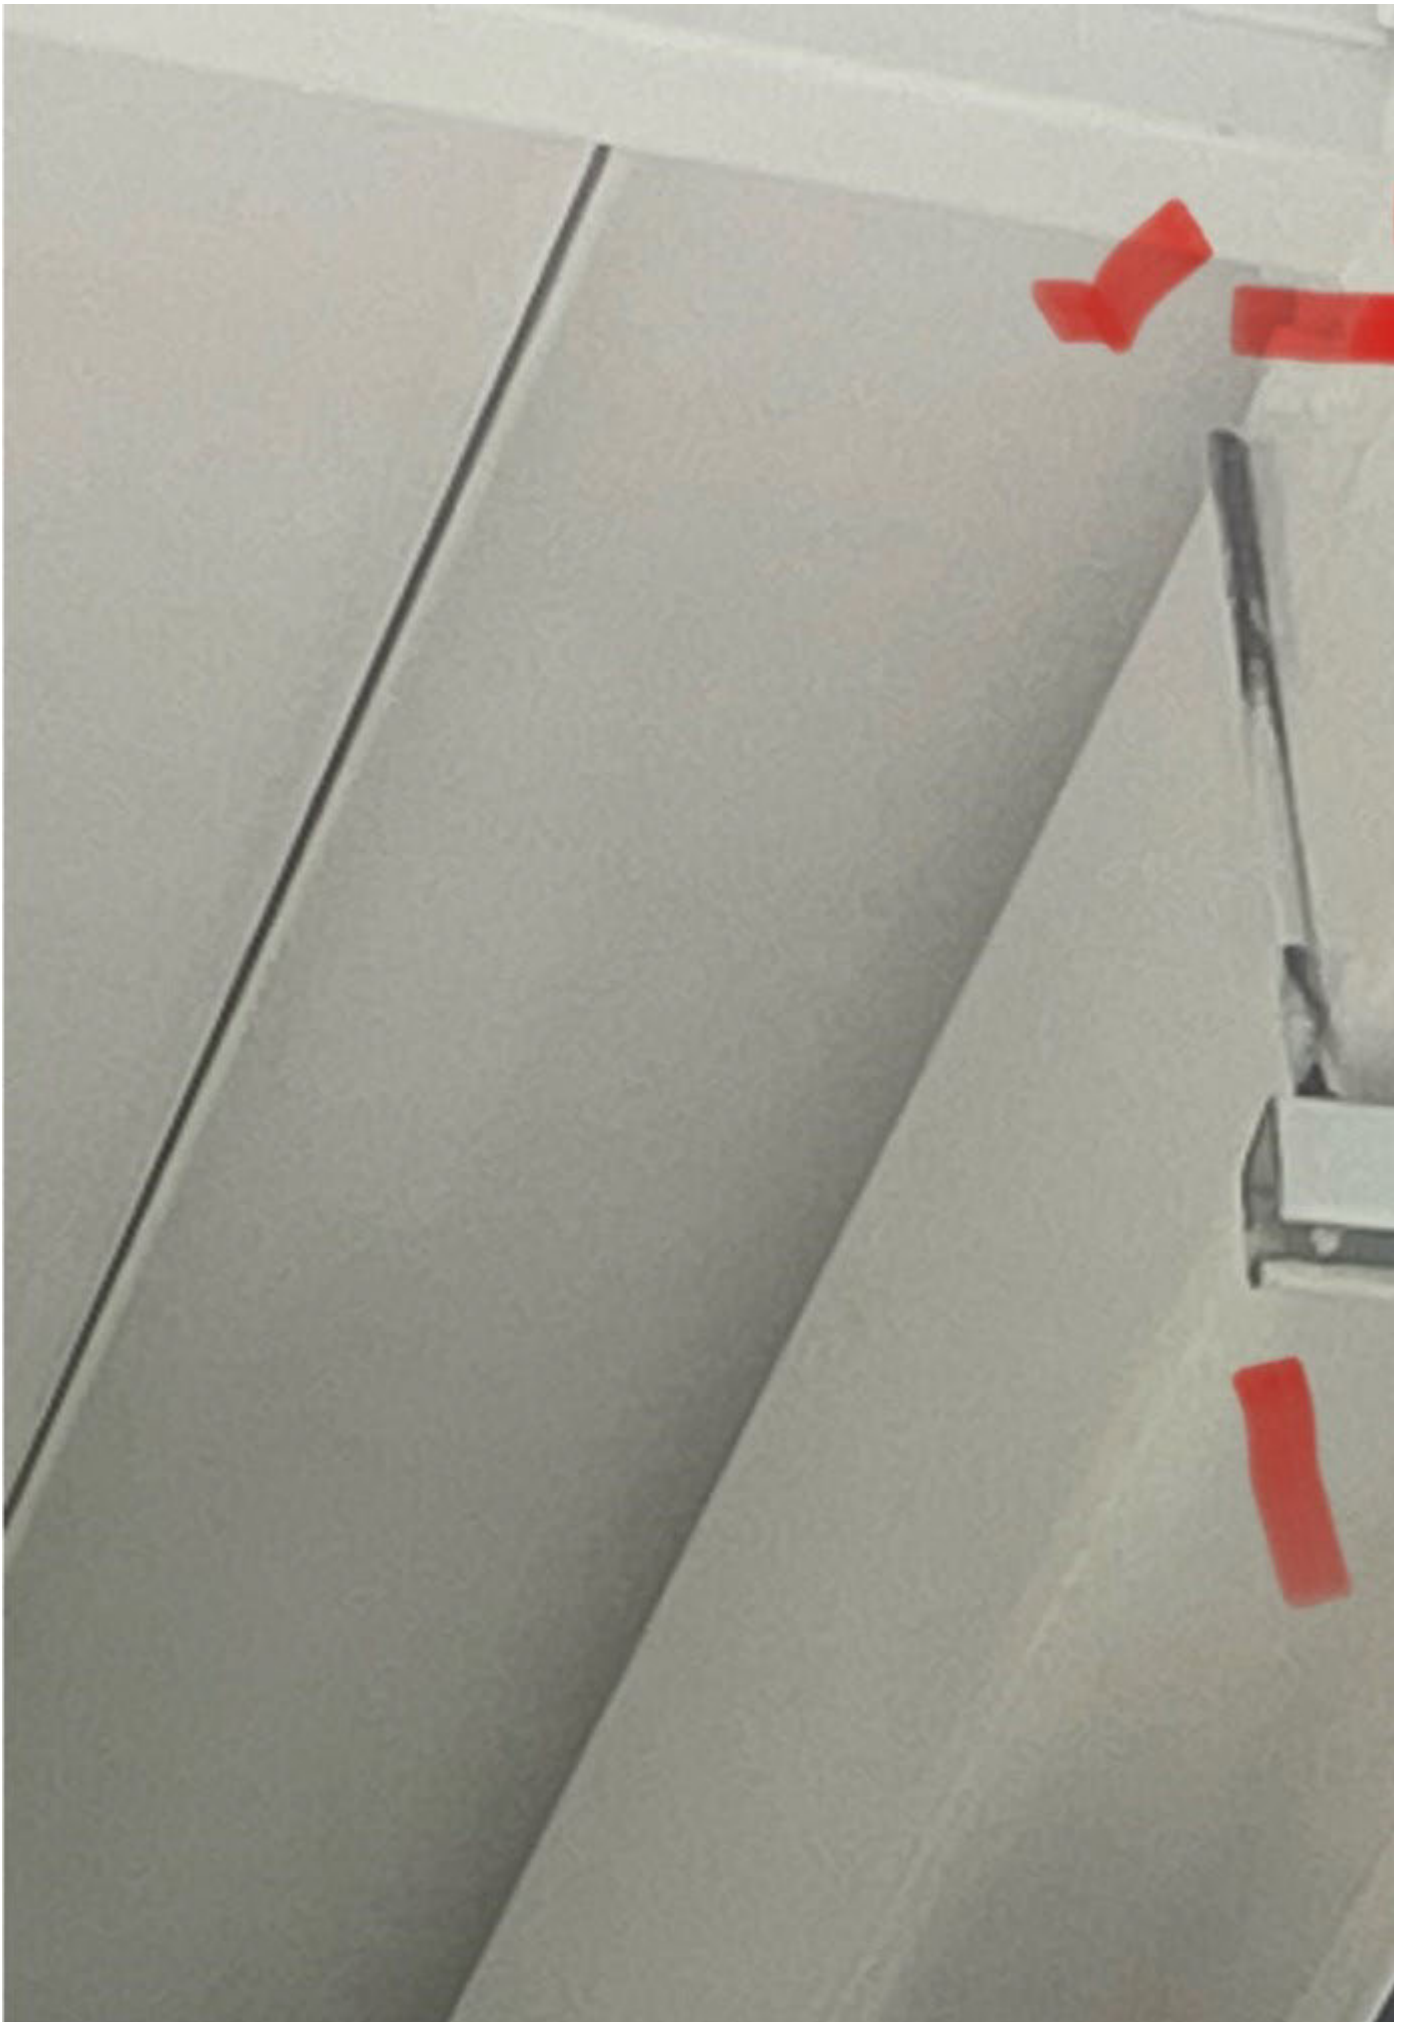
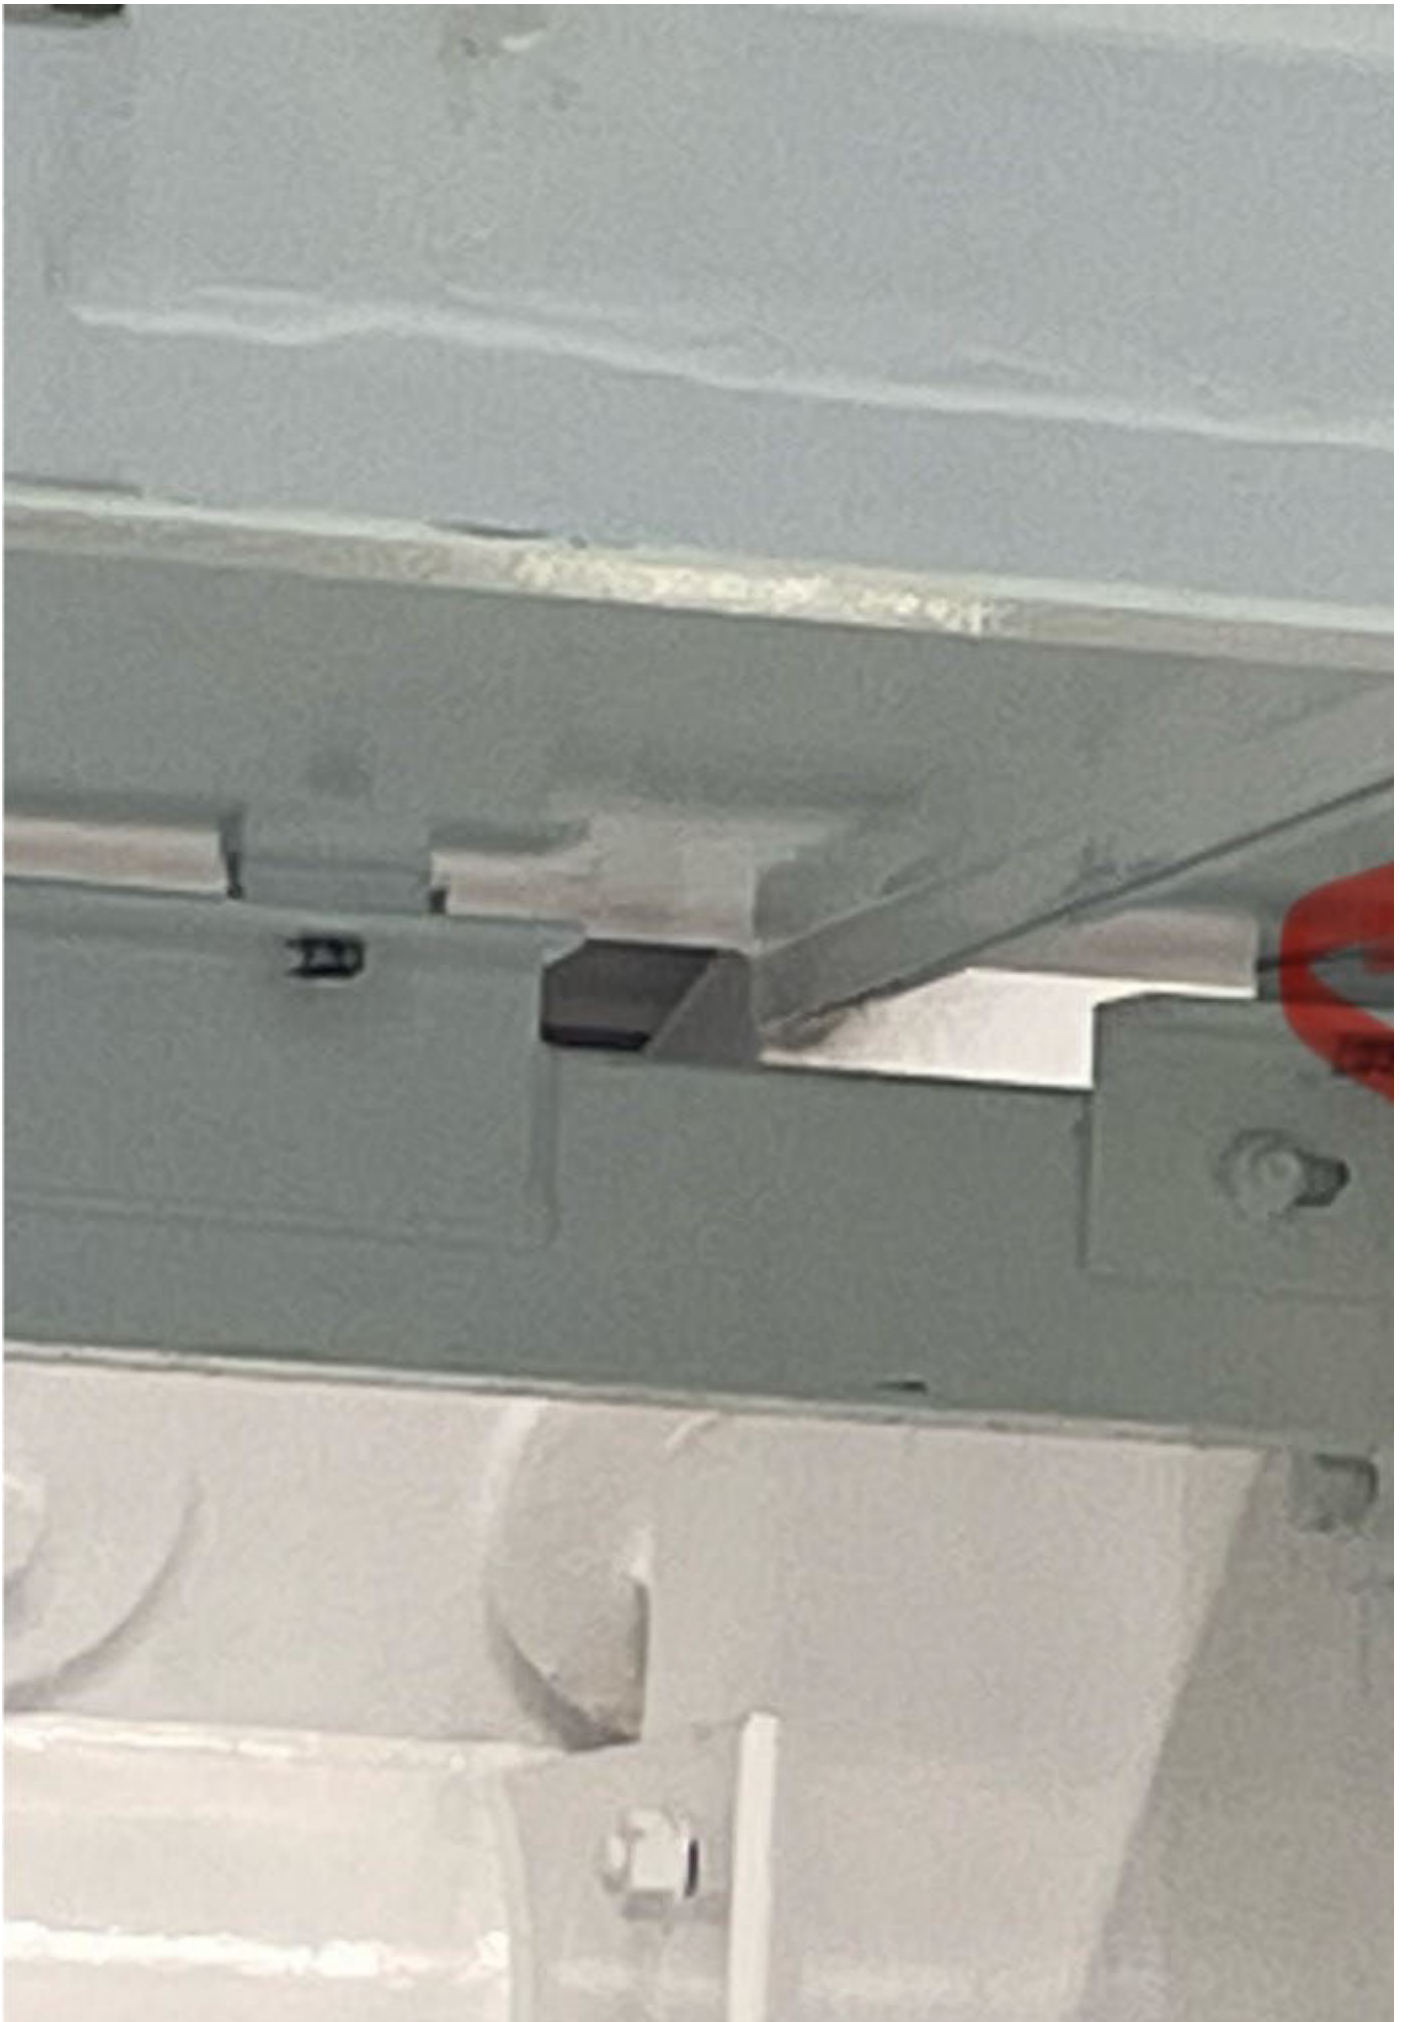
**Issue three:** unsecured joint.

There are two more pins sitting unsecured. There is a missing bracket that should be above the beam which the pins slot into. In orange you can see where Saturdays pin fell and the burst pipe. Suggestion was from discussions with [REDACTED] [REDACTED] that the weight from the lack of support has contributed to the pipe bursting. [REDACTED] recons that its not likely to have done so.

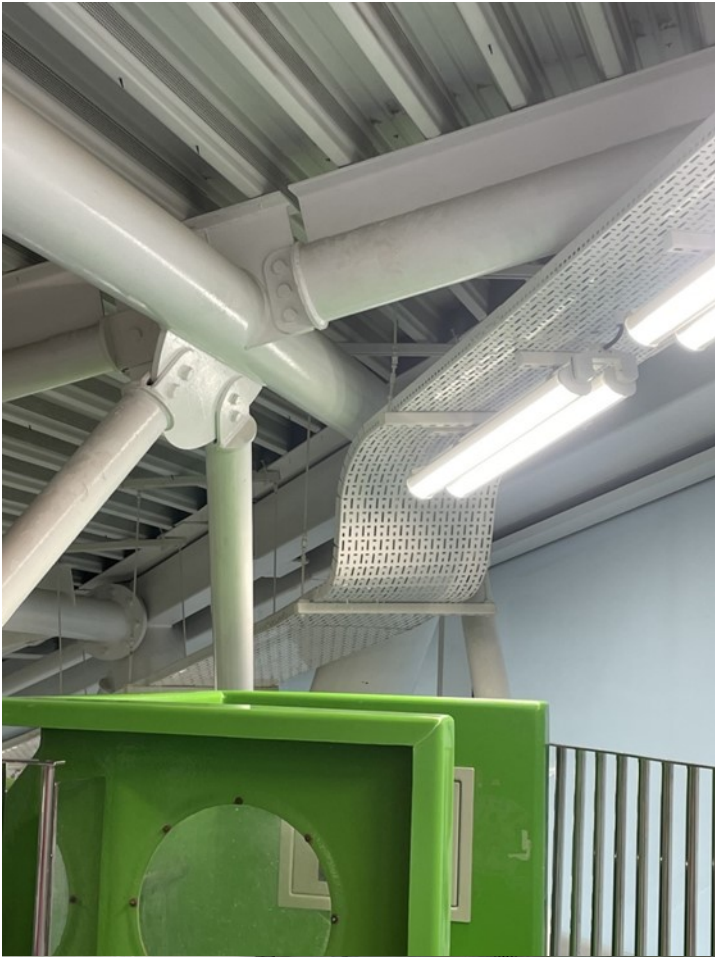
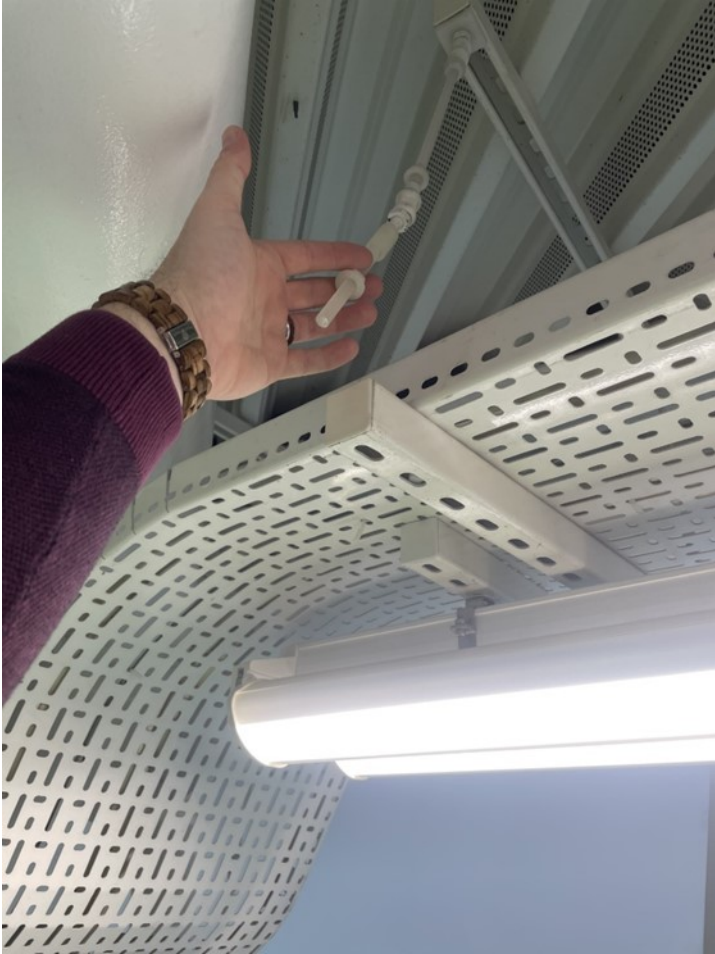
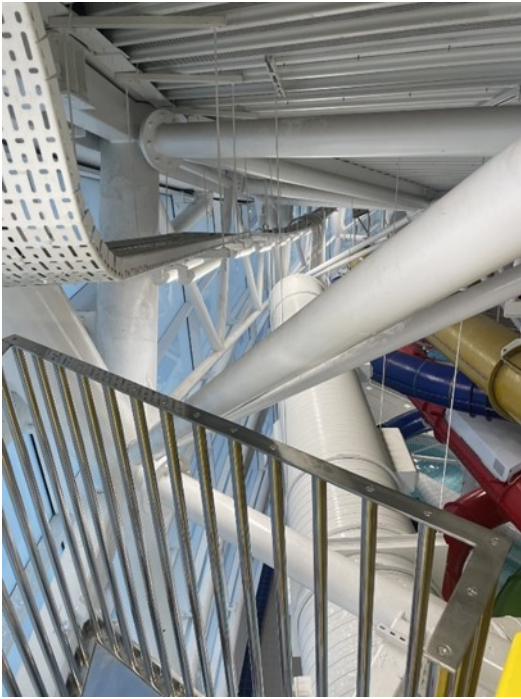
**Issue two identified today:** supports for electrics

Like the first issue these ducting's are around the pool hall and not just restricted to the flume tower area.

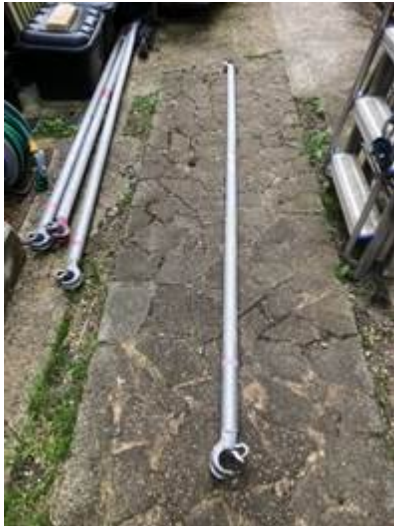
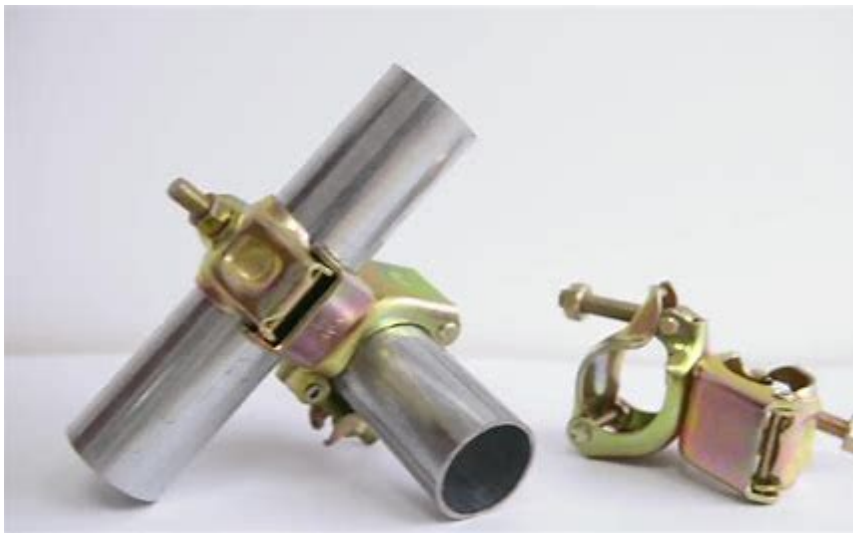
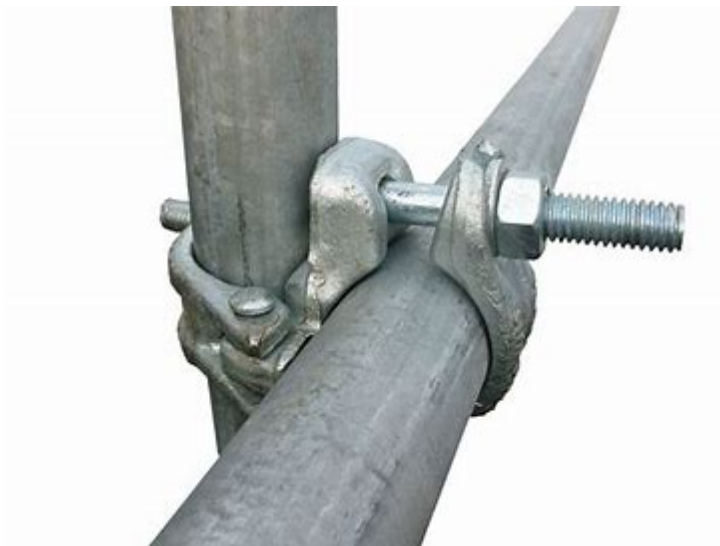
The issue is the gap between the lower bar and the platforms on the 3m and 5m boards. It requires a physical barrier.

- **Temporary measure:** To that end in the short term I have a second proposal that we utilise scaffolding bars and fixings to form a barrier into that space.
- **The fix:** This would then be replaced by City Development with a set of fixed bars in those low gaps.

This would have to take a physical weight, with assurances around if someone impacted upon it. The bolts would have to be positioned so that they cannot be unintentionally kicked on the way past. It cannot fail due to being hit or braced against. I stress this would be a temporary measure until the horizontal fixed bars are welded onto the gaps at the 3m and
