## **ITEM No ...4.....**

**REPORT TO:** CITY GOVERNANCE COMMITTEE - 22 SEPTEMBER 2025  
**REPORT ON:** OLYMPIA  
**REPORT BY:** CHIEF EXECUTIVE  
**REPORT NO:** 246-2025

1.1 The purpose of this Report is to enable the Council to scrutinise the Report by Burness Paull, Solicitors, regarding the closure of the Olympia Swimming and Leisure Centre in 2024 following £6.1m of capital investment by Dundee City Council.

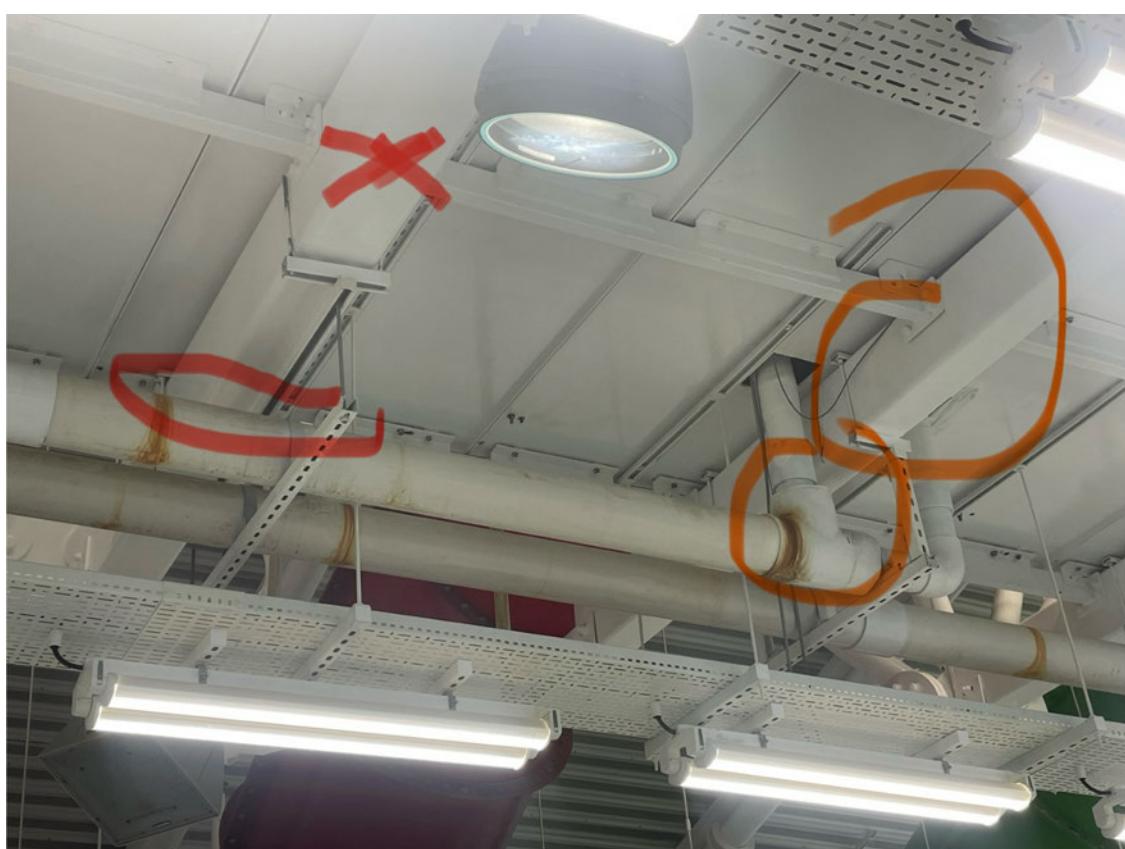
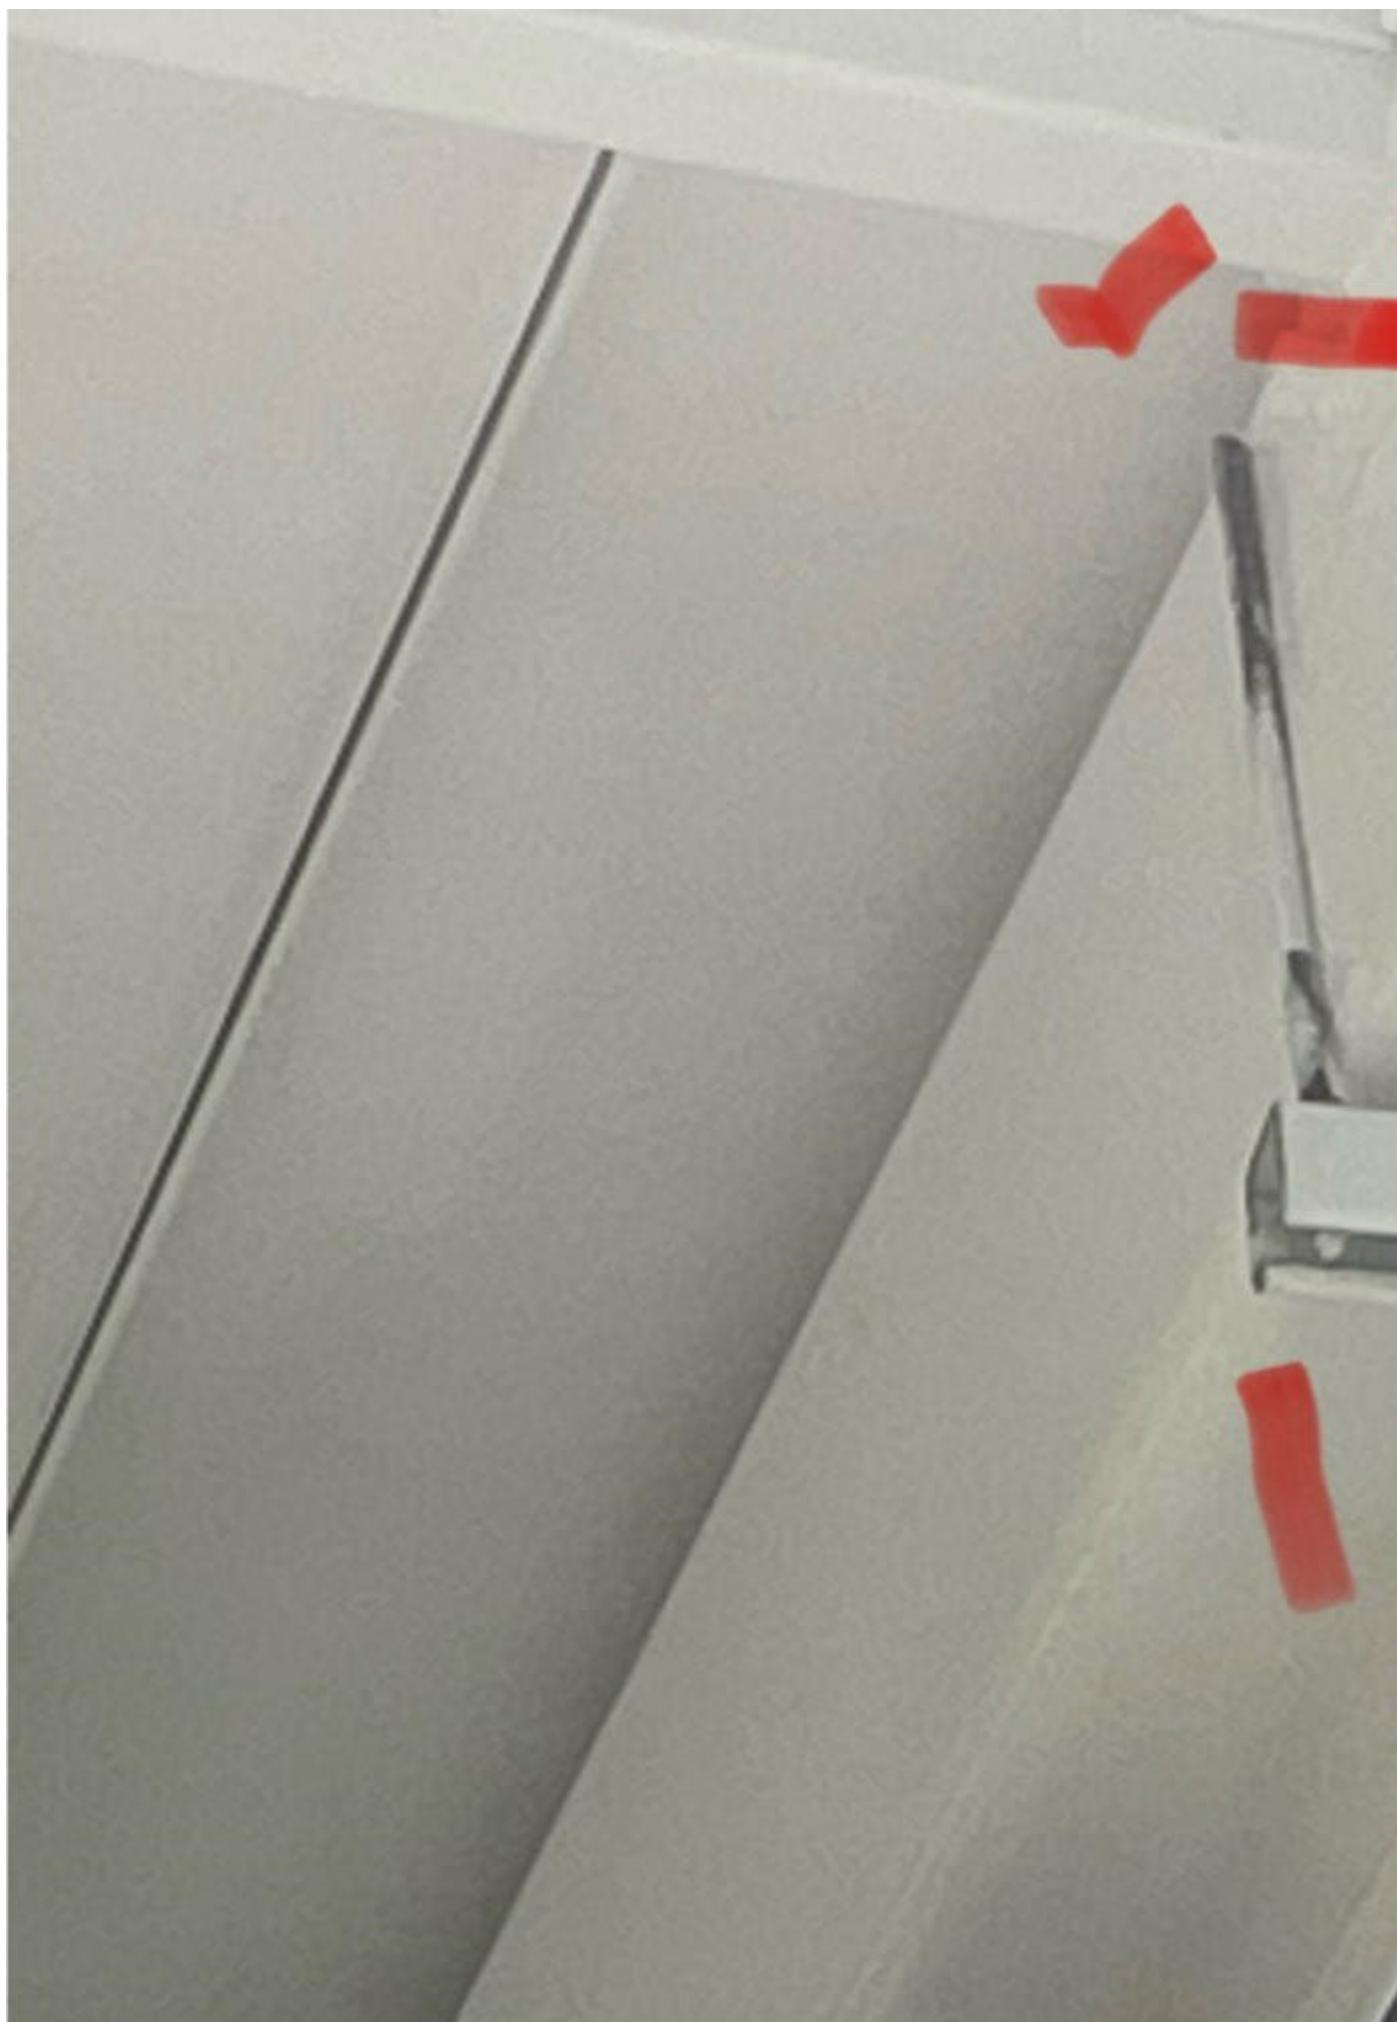
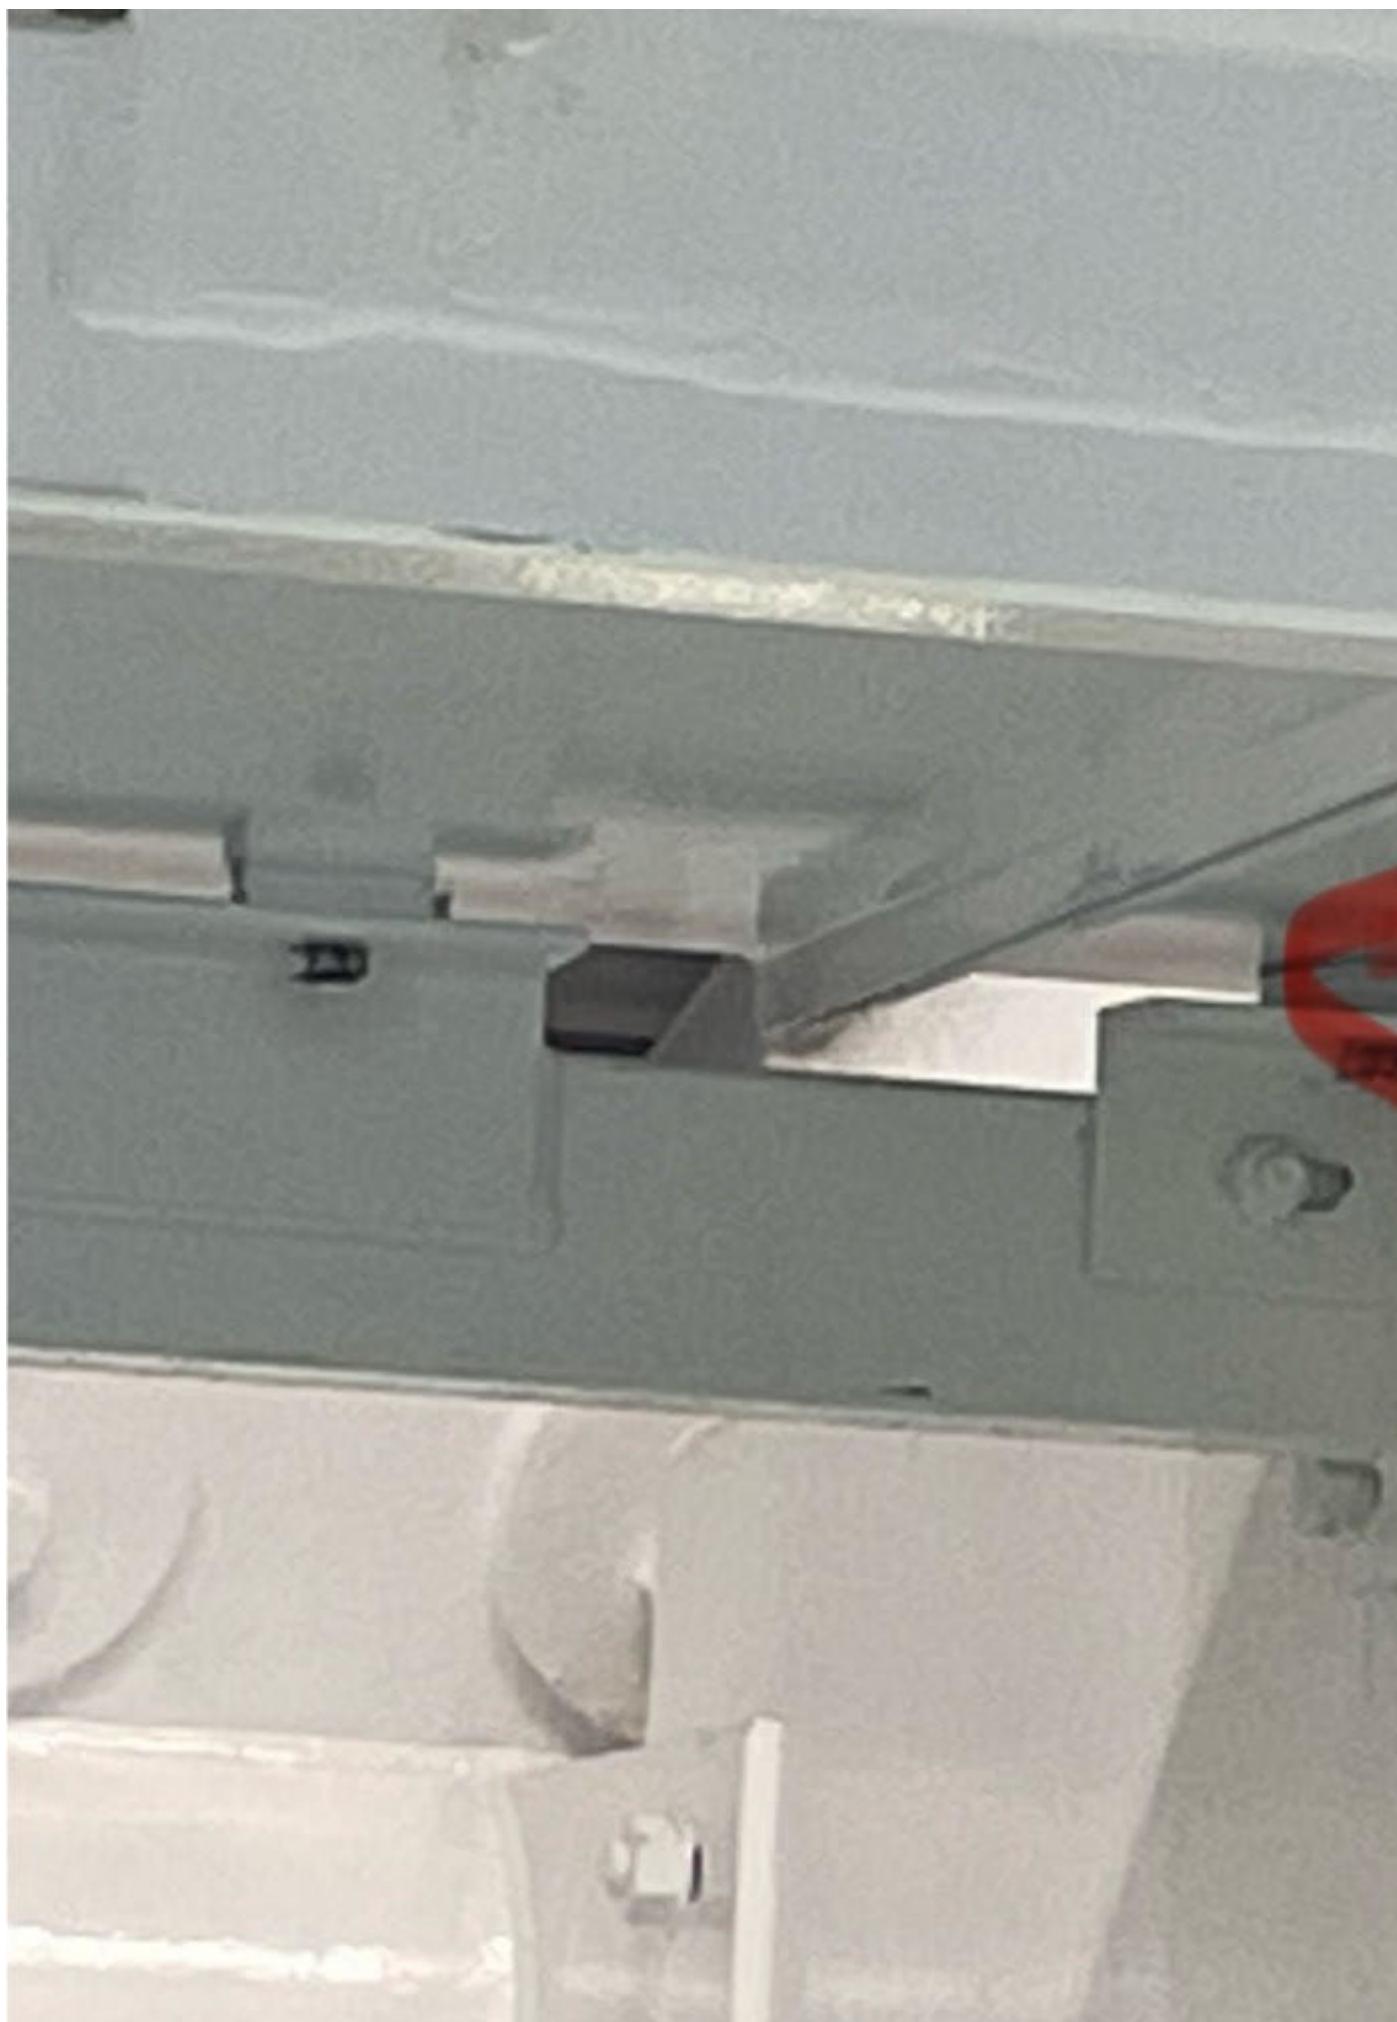
**Issue three:** unsecured joint.

There are two more pins sitting unsecured. There is a missing bracket that should be above the beam which the pins slot into. In orange you can see where Saturdays pin fell and the burst pipe. Suggestion was from discussions with [REDACTED] that the weight from the lack of support has contributed to the pipe bursting. [REDACTED] recons that its not likely to have done so.

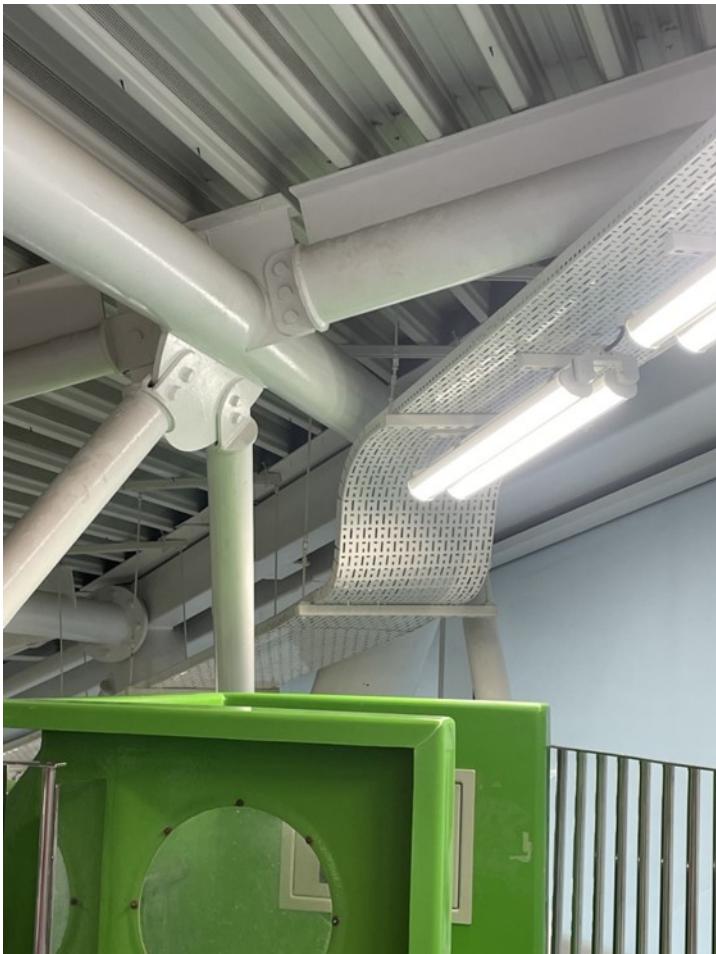
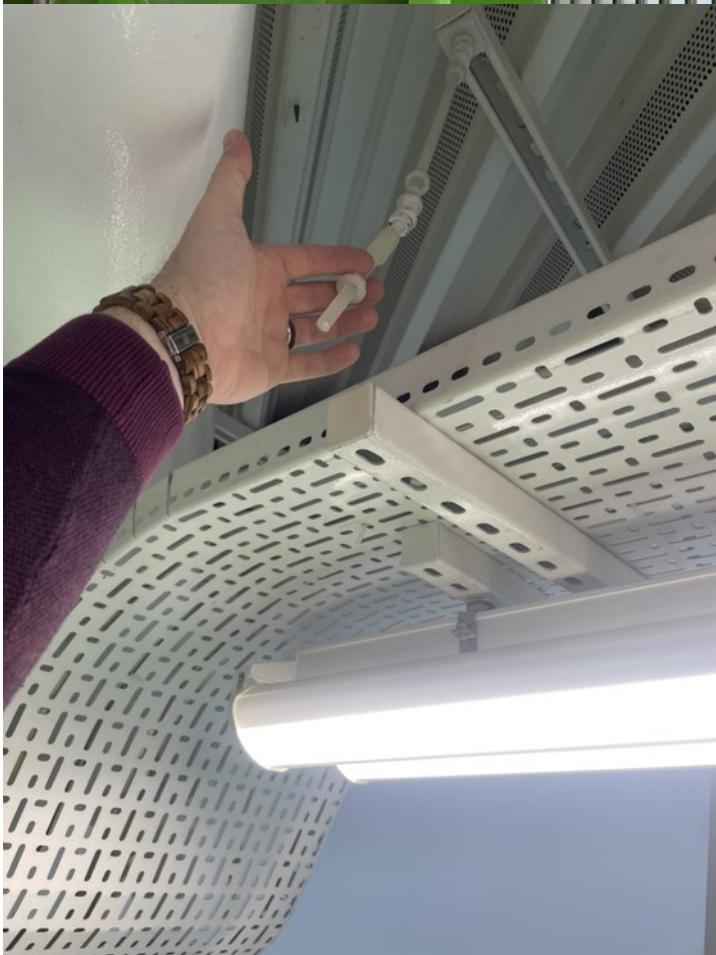
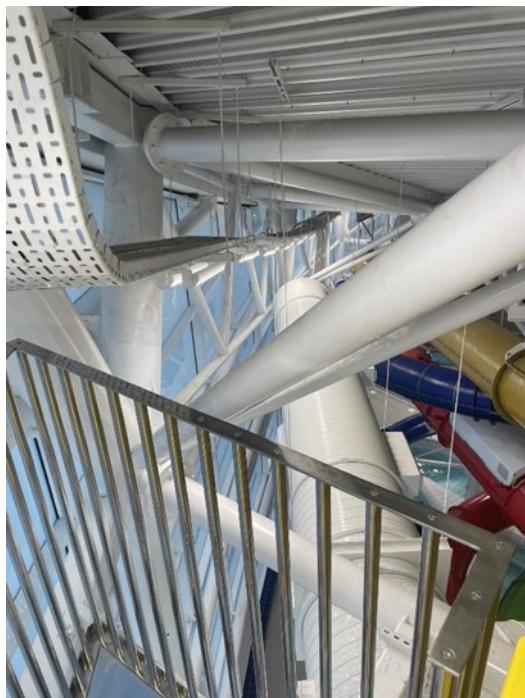
**Issue two identified today:** supports for electrics

Like the first issue these ducting's are around the pool hall and not just restricted to the flume tower area.

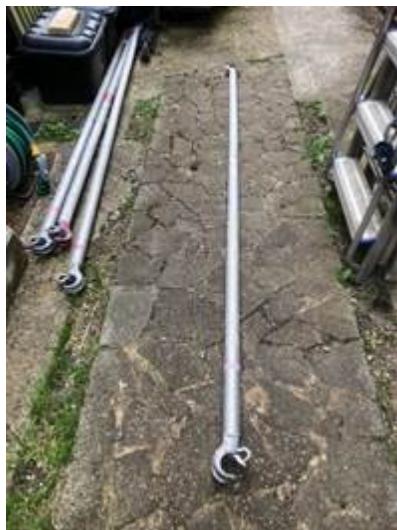
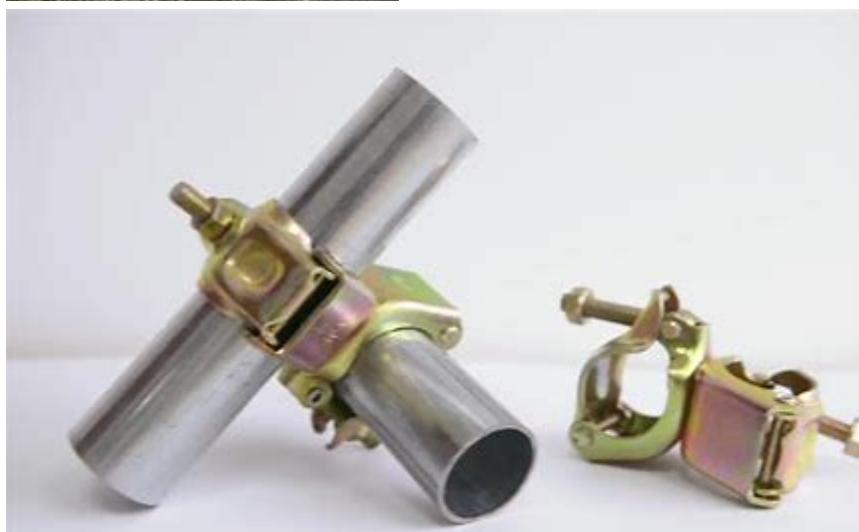
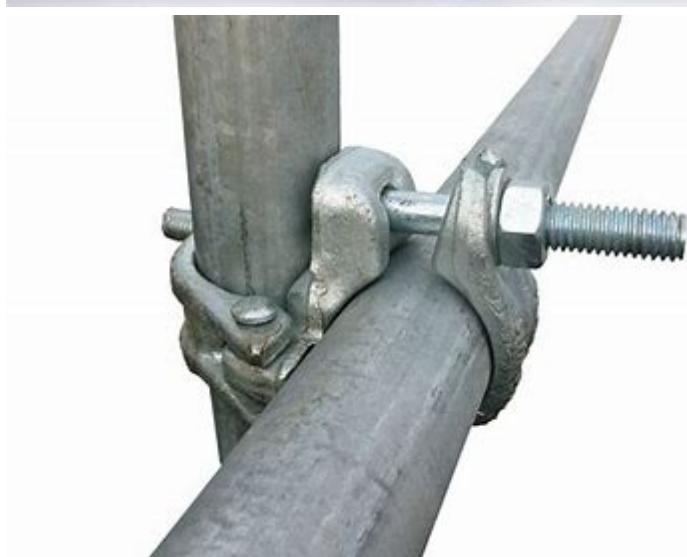
The issue is the gap between the lower bar and the platforms on the 3m and 5m boards. It requires a physical barrier.

- **Temporary measure:** To that end in the short term I have a second proposal that we utilise scaffolding bars and fixings to form a barrier into that space.
- **The fix:** This would then be replaced by City Development with a set of fixed bars in those low gaps.

This would have to take a physical weight, with assurances around if someone impacted upon it. The bolts would have to be positioned so that they cannot be unintentionally kicked on the way past. It cannot fail due to being hit or braced against. I stress this would be a temporary measure until the horizontal fixed bars are welded onto the gaps at the 3m and
