# Conservation Area

Trottick Conservation Area Appraisal

## 1.0 Introduction

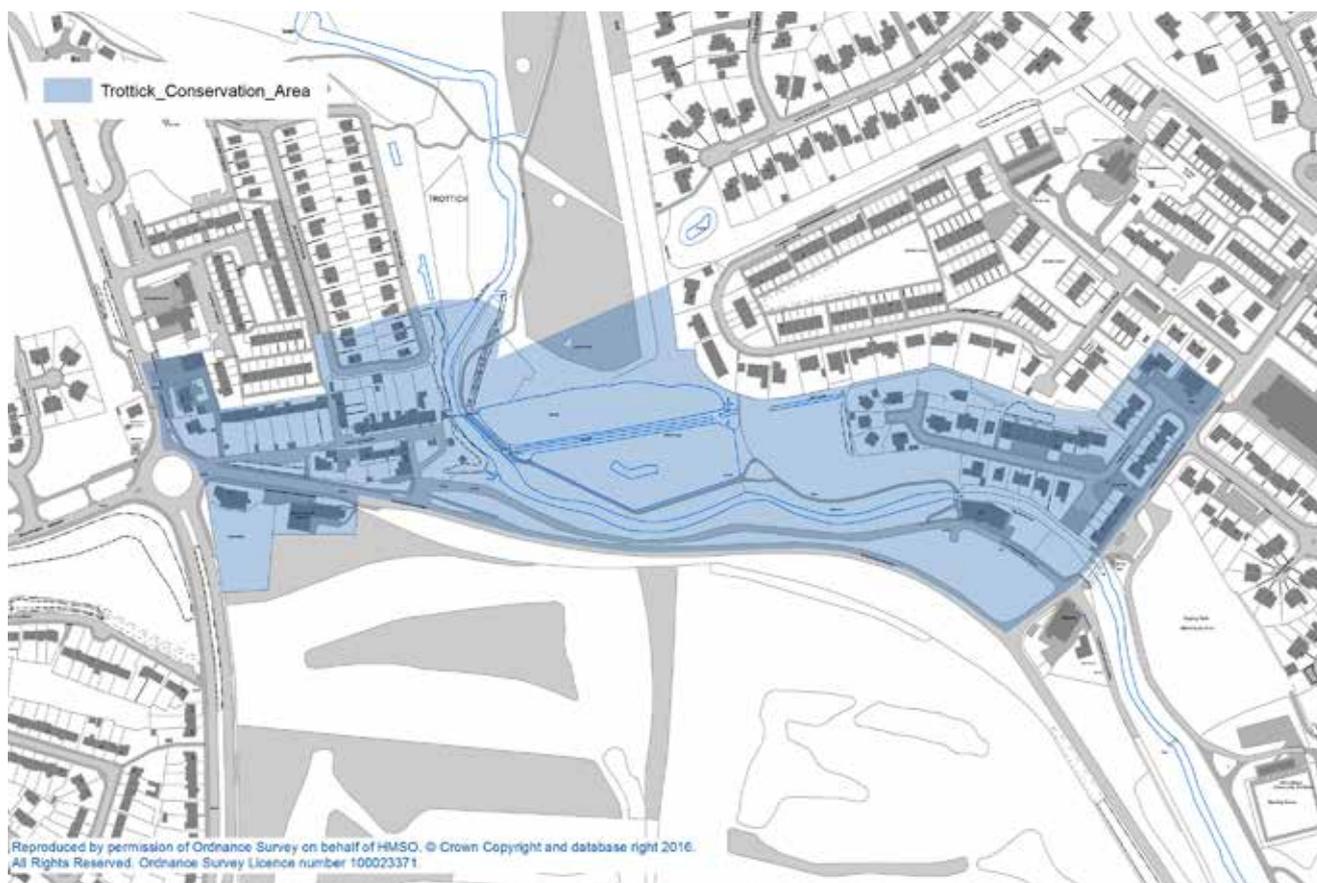
*Fig 1 – Current Boundary*

The Conservation Area boundary starts at the existing nursery on Claverhouse Old Road, running westwards to the south of Claverhouse Road; incorporating Mains Parish Church and turning northwards at the eastern edge of Old Glamis Road; incorporating the eastern half of the carriageway of Old Glamis Road to the north of the roundabout; turning east then south then east to incorporate the properties at Trottick Mains; then north and east to include 6 properties on Millburn Gardens; continuing east to incorporate the Dighty Water up to the rear boundaries of the properties at Mansion Drive; then continuing east then south to include the properties at Heron Rise; continuing southwards along Barns of Claverhouse Road back to the nursery on Claverhouse Old Road.

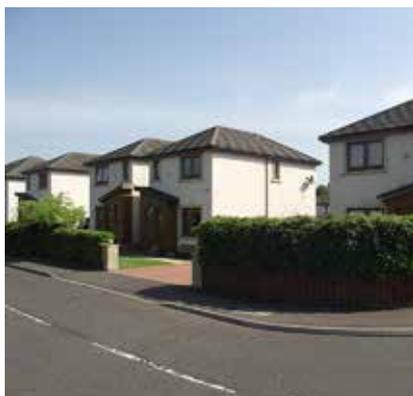
*Millburn Gardens*

On review of the Conservation Area boundary, an opportunity has been highlighted to rationalise the northern boundary of the Conservation Area to exclude the southern-most properties at Millburn Gardens as well as the commercial properties on Old Glamis Road. The original boundary was prepared in 1971 and therefore pre-dates the construction of the residential properties at Millburn Gardens.

Altering the northern boundary line to exclude these properties is seen as a positive step in ensuring that the character and appearance of the Conservation Area is preserved.

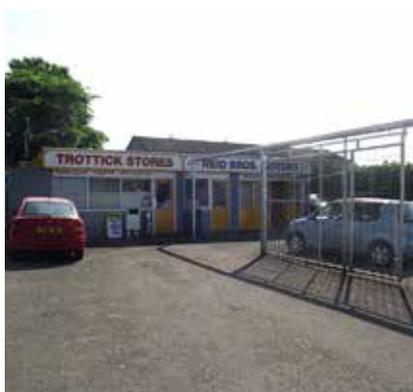
*Convenience Store & Car Sales*

Likewise, the property at 253 Old Glamis Road, currently used as a convenience store as well as a small car sales shop, is non-traditional in appearance and form, and currently is not in keeping with the character and appearance of the Conservation Area.

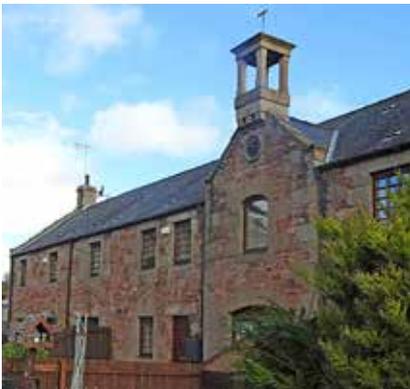
*Converted Mill Heron Rise*

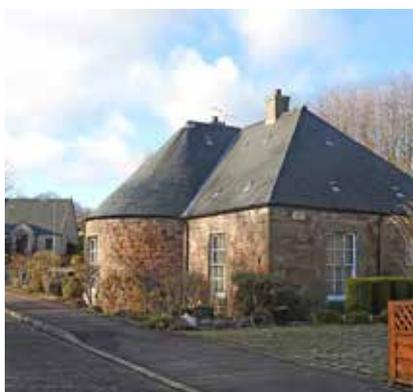
*Original Mill Cottage*

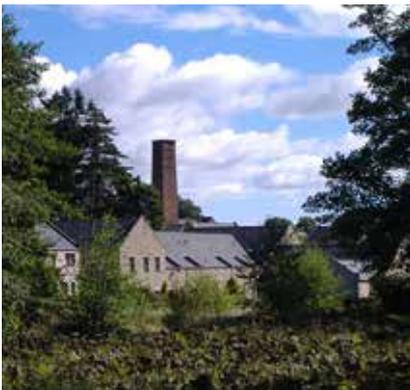
Looking east from the nature reserve, there is a view to the listed buildings of Heron Rise, taking in the Chimney stack and converted mill.

*Chimney Stack & Converted Mill*

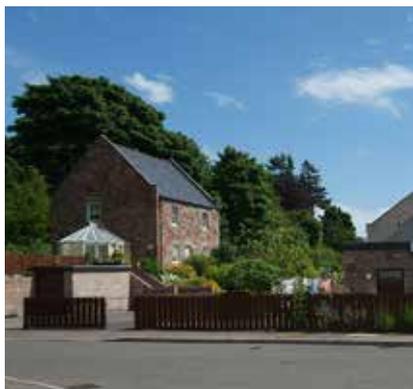
*Sandstone Buildings*

The Trottick Conservation Area utilises a number of traditional building materials with buildings constructed using locally sourced sandstone. Other materials can be found throughout the Conservation Area:-

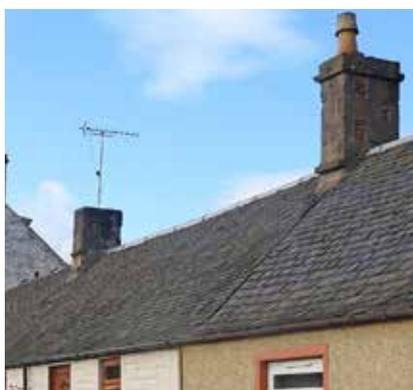
*Slate Roofs*

The predominant roofing material found within the Conservation Area is grey slate, extensively used from the late 18th century onwards, contributing significantly to the character and appearance of the area. However there are also more modern additions which detract from the character and appearance of the conservation area and have a shorter life span.

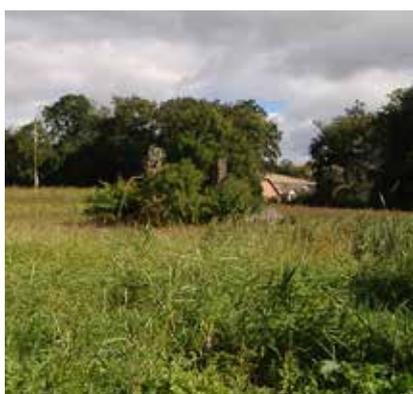
*Artificial Ruin*

A significant proportion of the Conservation Area is taken up by a Nature Reserve with pathways connecting Trottick to Dundee's Green Circular. A folly has been present since the 1859-1894 town plans were compiled. It currently stands in inaccessible scrubland almost completely obscured by trees with a high metal fence surrounding. There is a possibility that when the masonry of Claverhouse Castle was removed in c.1826, the stones from the castle may have been used to create the ruin.

The folly to the north of the Nature Reserve has no signage indicating its importance or detailing its history. If it is to remain in the Conservation Area after the boundary review concludes, there is perhaps the opportunity to provide heritage enthusiasts and local residents of the area with some context of the history of the site.

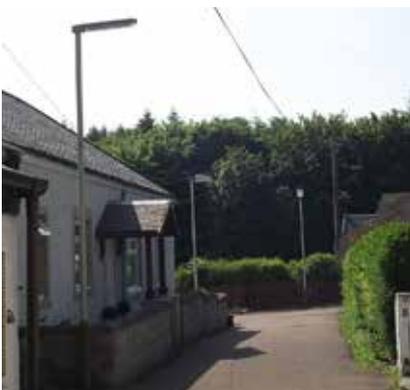
*Variety of Street Lighting*

Lamp standards within the conservation area vary in style from one lamppost to another, particularly in the Trottick West area. If proposals are brought forward to alter the street lighting, a uniformed approach would help minimise the impact on the character and appearance of the area and offer an opportunity for enhancement.

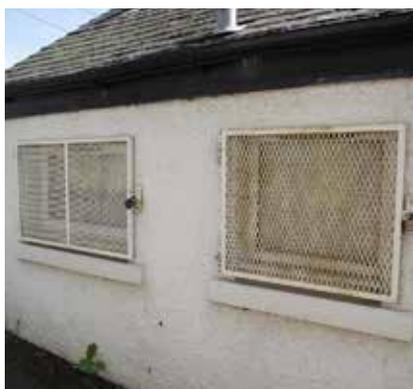
*Security Grilles*

Several windows at ground level make use of steel grilles for security.

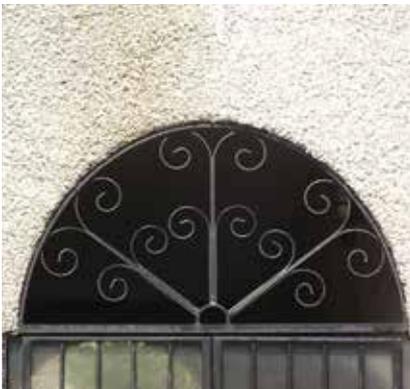
*Decorative Railing*

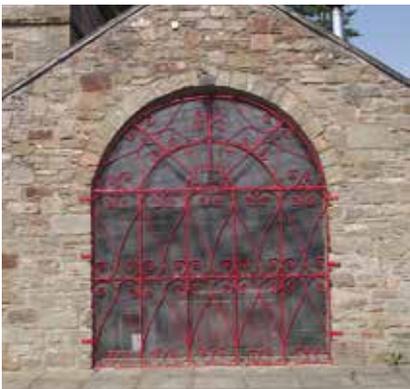
*Security Grille*

The office and chimney stack in Trottick East have made similar attempts at security in keeping with the character of the conservation area by incorporating styles found on the former Bleachfield manager's house on the south side of the Dighty.

There are obvious attempts at tying in new features to the existing character of the area, as evidenced in the security grille around the offices of the chimney stack and the decorative railing of the new build.

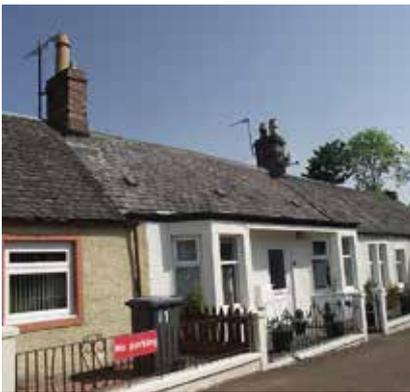
*Modern replacement windows*

The streetscape within the Trottick Conservation Area has suffered in some areas as a result of the unsympathetic replacement of traditional timber frame windows. The character of many of the buildings is enhanced by the traditional timber sash and case windows and incremental erosion of this important feature has had a significant adverse effect on the character and appearance of the area, particularly in Trottick West. Reinstatement of traditional windows should be encouraged in place of unsympathetic non-traditional glazing.

Replacement of windows within a Conservation Area will require to comply with the Council's policy on replacement windows and doors, and also the advice and guidance set by Historic Environment Scotland. Applications for inappropriate replacement windows and doors shall be recommended for refusal.

When the opportunity arises it would be in the interest of the Conservation Area to have the reinstatement of a more appropriate design and style of window and door which fits the character of the property. This shall help further enhance the character and appearance of the area.

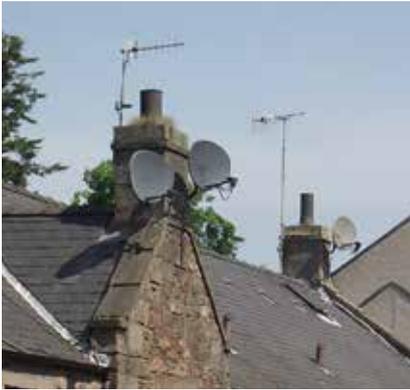
*Satellite dishes*

Television aerials and satellite dishes located on roof exteriors detract from the appearance of the Area, though this negative issue is also prominent in Trottick West. Consideration should be given to the location of all such devices within roof spaces or other less obtrusive positions. Detailed advice on best practice on the location of satellite dishes can be obtained from Dundee City Council's City Development Department. The advice set out for satellite dishes can be applied equally to television aerials.

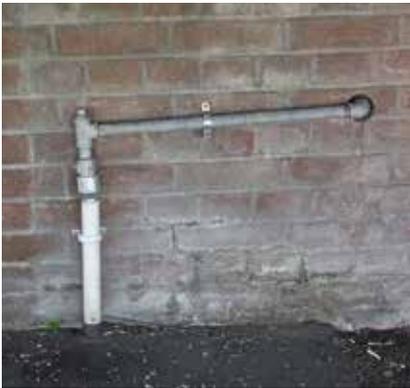
*Pipes*

Works carried out by utility companies and by statutory bodies must have regard for the character of the conservation area. Cables and pipes which run over the outside of wall detract from the appearance of the wall and from the overall appearance of the conservation area. The installation of pipes and cables should be hidden from view, and in accordance with guidance set by Historic Environment Scotland.

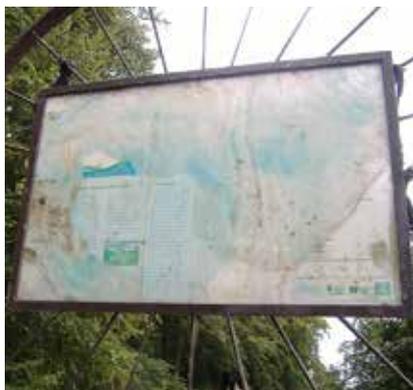
*Signage in the Nature Reserve*

There is some opportunity for improvements to signage available in the Nature Reserve.

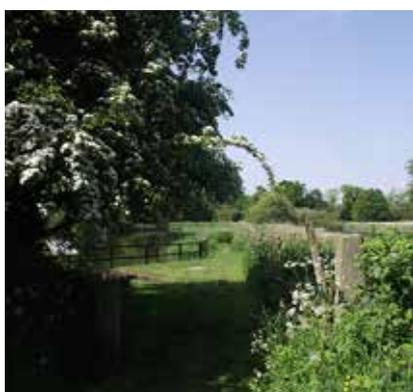
Although Trottick East exhibits multiple attempts at continuity, the residential area west of the Nature Reserve displays a number of opportunities for enhancement. There are also opportunities for continuity improvement in the Nature Reserve. Public benches are wrought iron painted black whereas railings are dark stained wood and bollards are unstained wood. Ensuring future improvements to the Reserve were in keeping with the character of the area by using the same materials would enhance the character of the area.

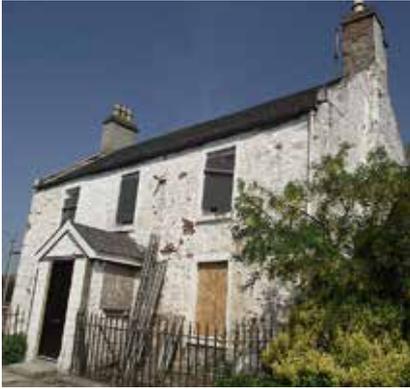
Nos. 8 and 14 Trottick Mains and Mains of Claverhouse are currently both under development. This provides an opportunity for the council to ensure that architectural features are restored to historic buildings.
