**REPORT TO:** CITY GOVERNANCE COMMITTEE - 22 SEPTEMBER 2025

**REPORT ON:** OLYMPIA

**REPORT NO:** 246-2025

- 1.1 The purpose of this Report is to enable the Council to scrutinise the Report by Burness Paull, Solicitors, regarding the closure of the Olympia Swimming and Leisure Centre in 2024 following £6.1m of capital investment by Dundee City Council.

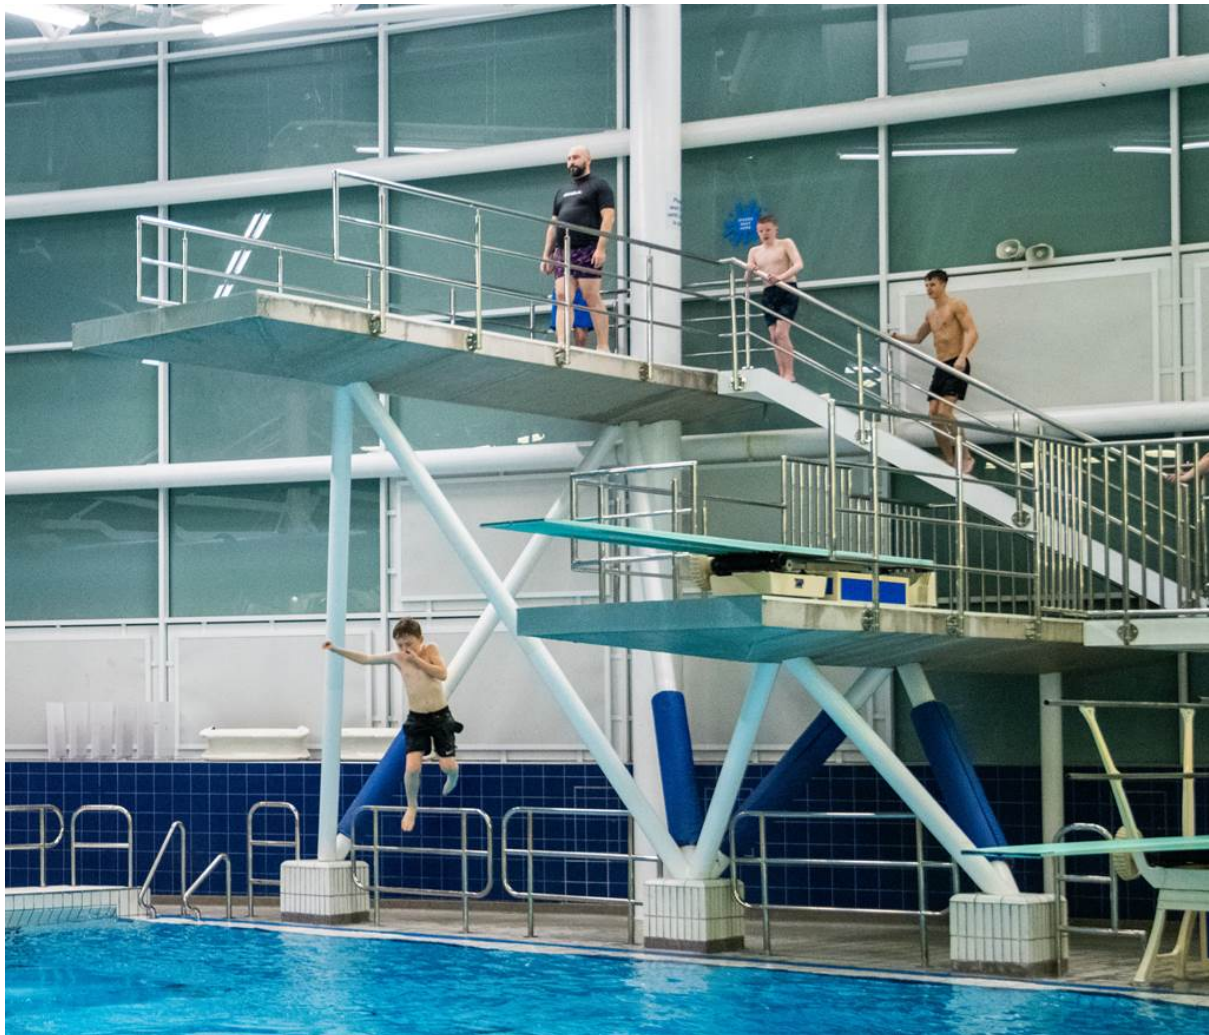
As we discussed I had a meeting this morning with Judy Dobbie (L&CD Managing Director) to follow up on discussions she was having with City Development. At the core of the issue that you have identified is that you feel that there is a potential risk of someone (particularly of child size) being able to slip and fall under the bottom spar of the high board. Judy and myself completely understand the position having now been given the history around this of the two previous accidents.
